Report on the investigation of the loss of the sailing yacht

Ouzo

South of the Isle of Wight

Report No 7/2007
April 2007

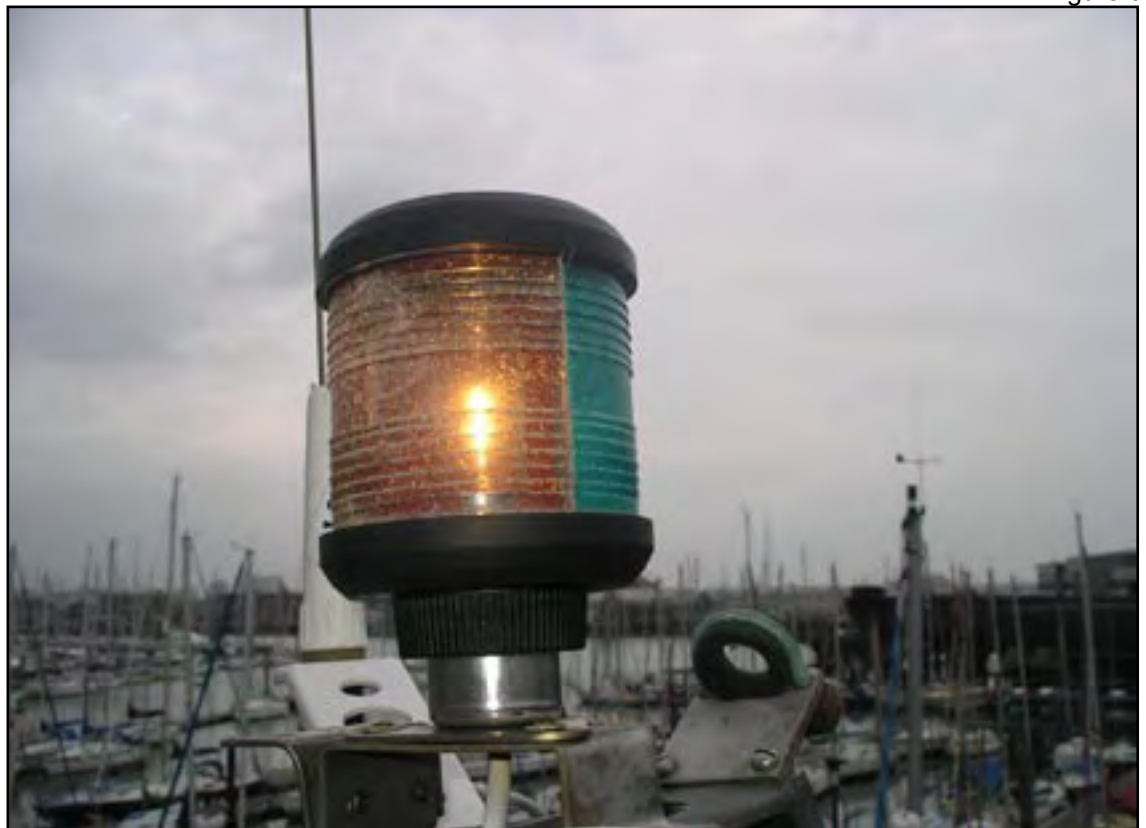
Figure 9

The investigation found that after a period of time, the lenses of combined plastic masthead units are prone to crazing as the plastic becomes diffuse due to heating from the lamp (bulb). This reduces the luminosity of the light (**Figure 9**).

The condition of the lights aboard is not known, but the unit had not been replaced since the boat was built. **Figure 9** shows a unit of similar age to the one on board *Ouzo*.

Combined top light

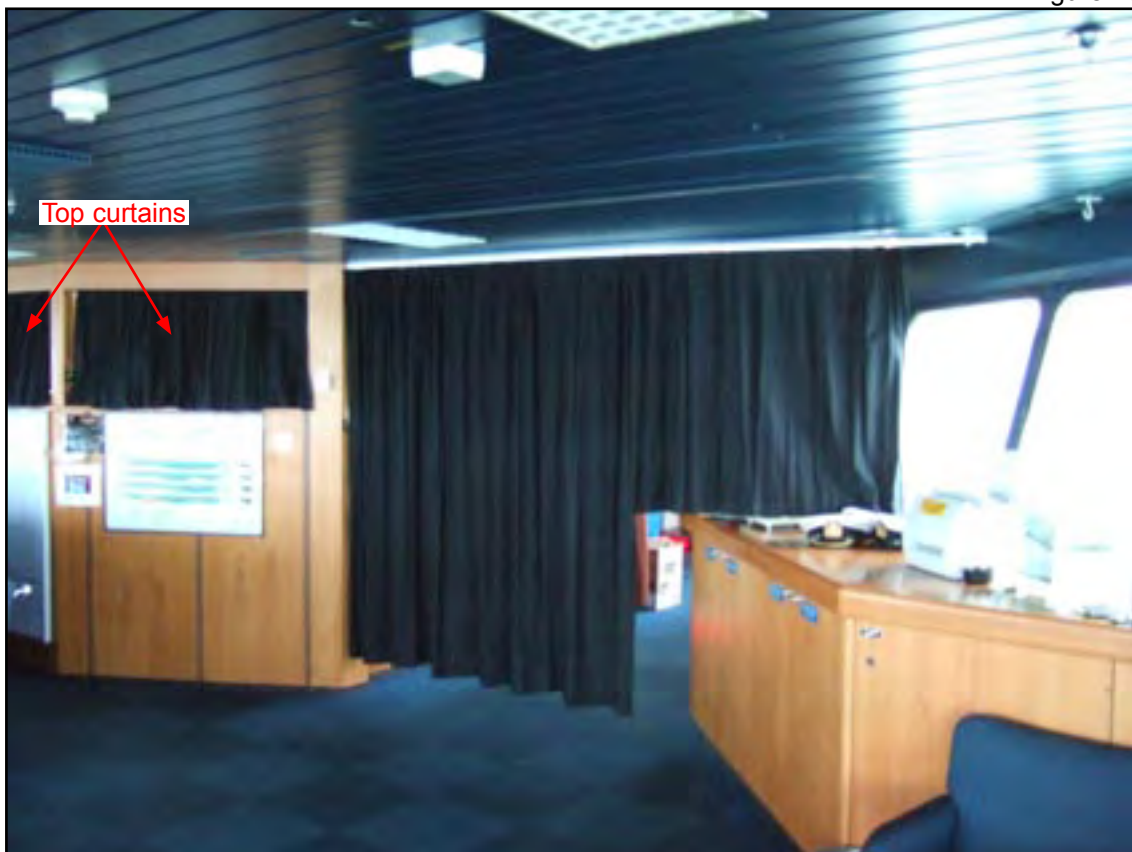
Figure 10

The second officer found that working under red light gave him headaches, and, on the night of the accident, as was his normal practice, he had removed the red screen and allowed the unfiltered white light to illuminate the chart table. This would have adversely affected both his night vision, because he was working in there during the watch, and the lookout's, as he had entered the chartroom after arriving on the bridge before taking over his watch.

Port side chartroom black out curtains

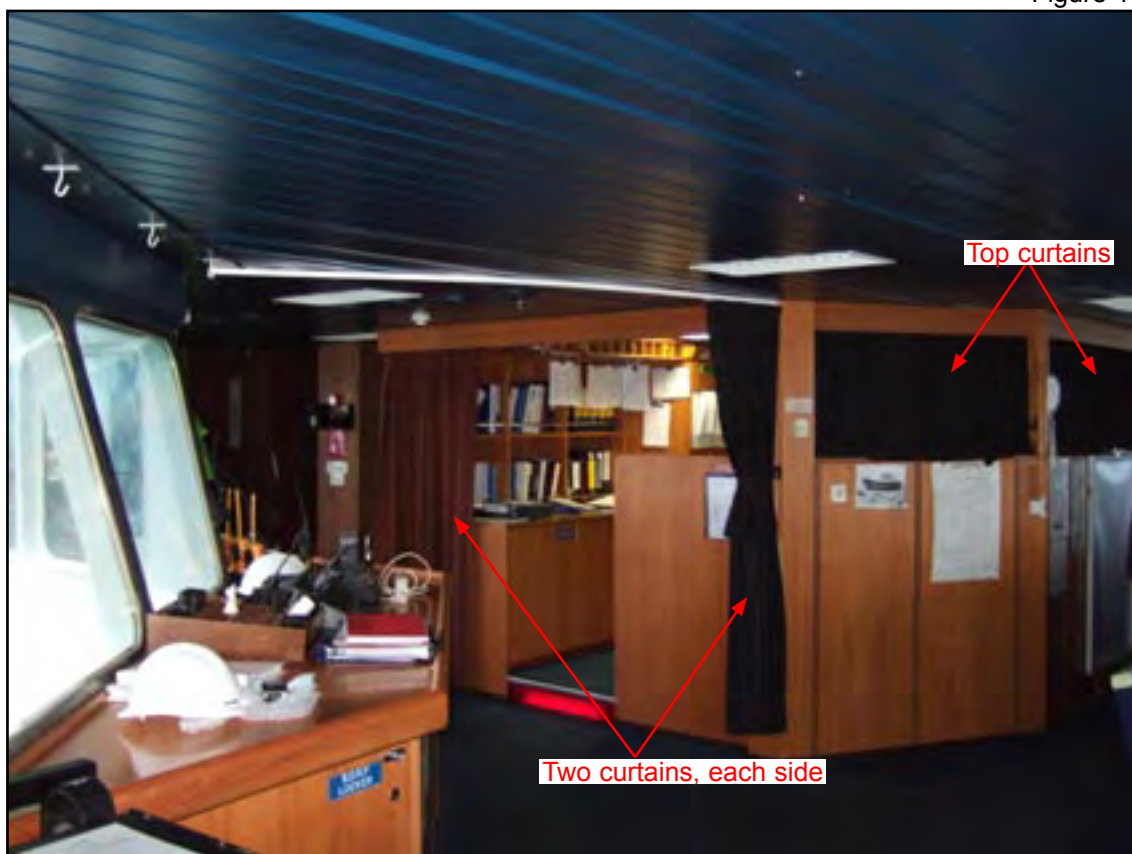
Figure 11

Starboard side curtains, and port side were in open position as shown

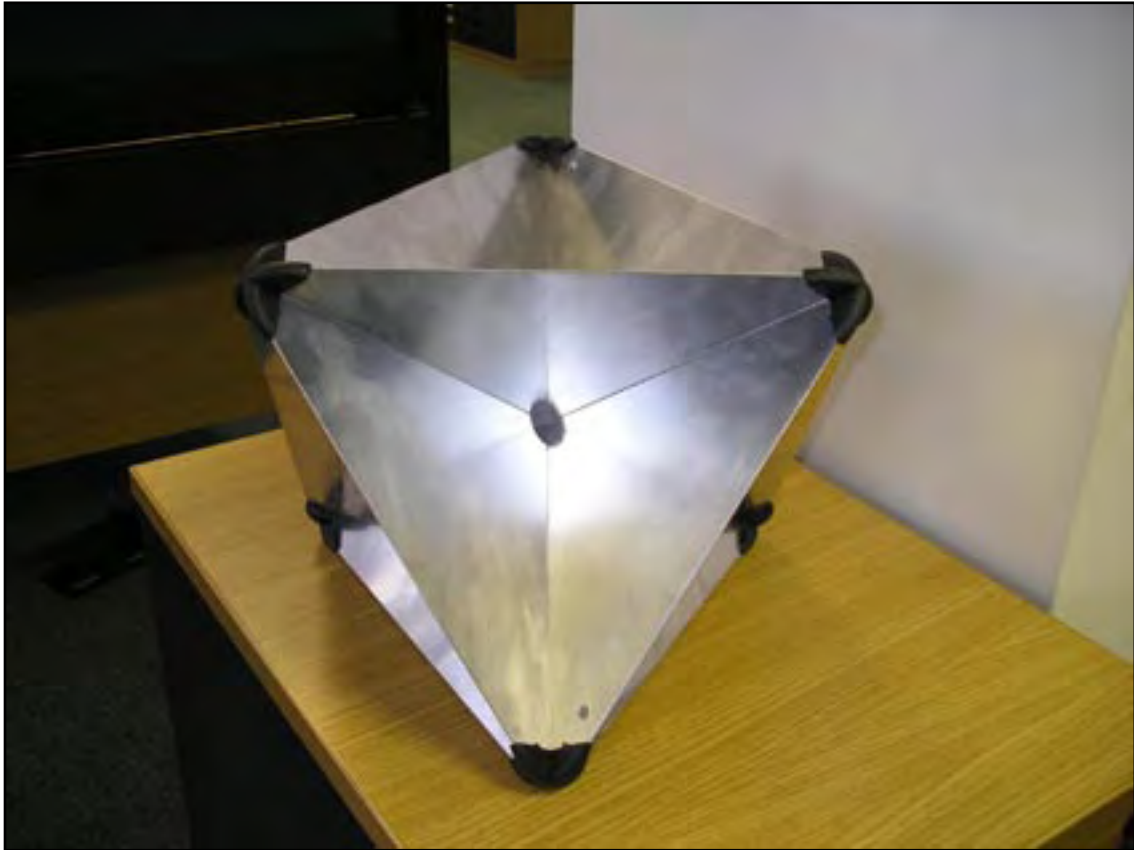
Figure 12

QinetiQ Funtington’s report (**Annex 4**) concluded that, bearing the above factors in mind, it was unlikely that deployment of the radar reflector on *Ouzo* would have made very much difference to the RCS of the yacht.

Octrahedral type radar reflector ("catch rain" position)

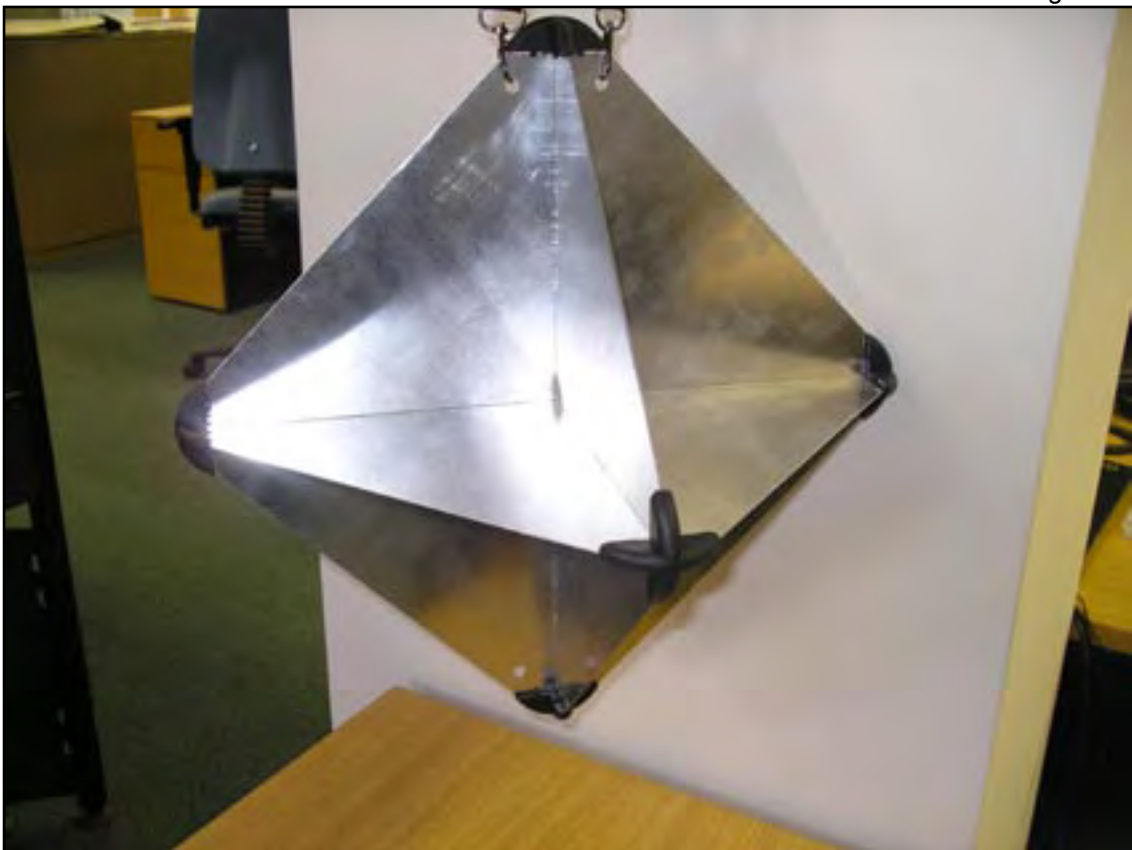
Figure 13

Radar reflector (not in "catch rain" position) suspended from the fixing points

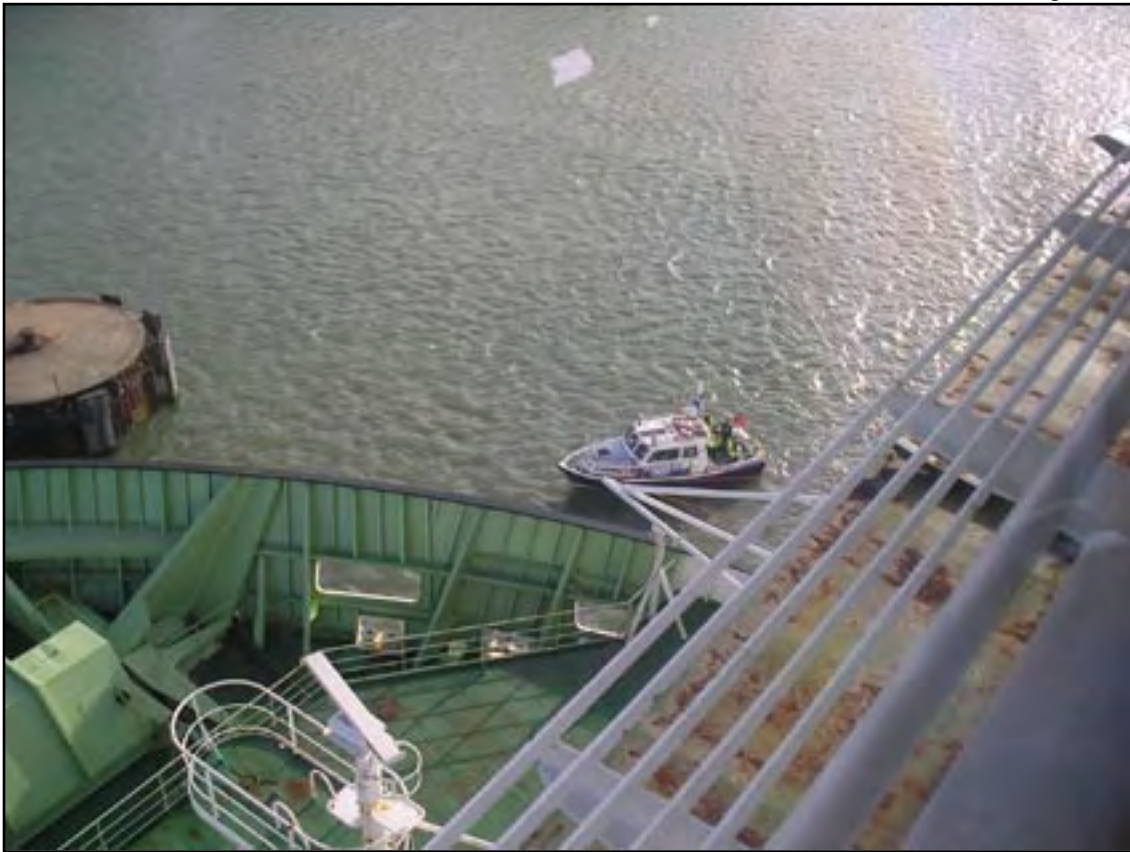
Figure 14

It is the firm view of the MAIB that a passing distance of 30 metres or less was unsafe for a small yacht in this situation.

Approximate position of *Ouzo* as she passed by

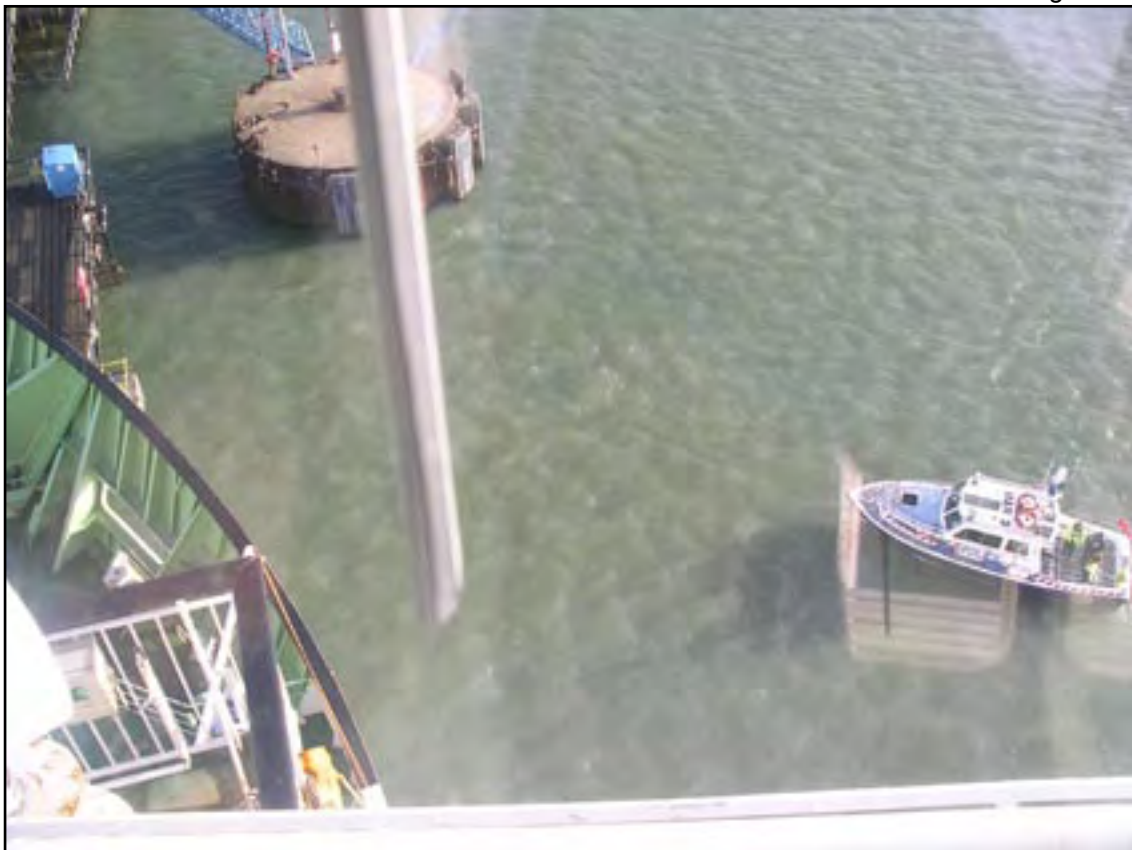
Figure 15

Approximate position of *Ouzo* looking down from starboard side of bridge

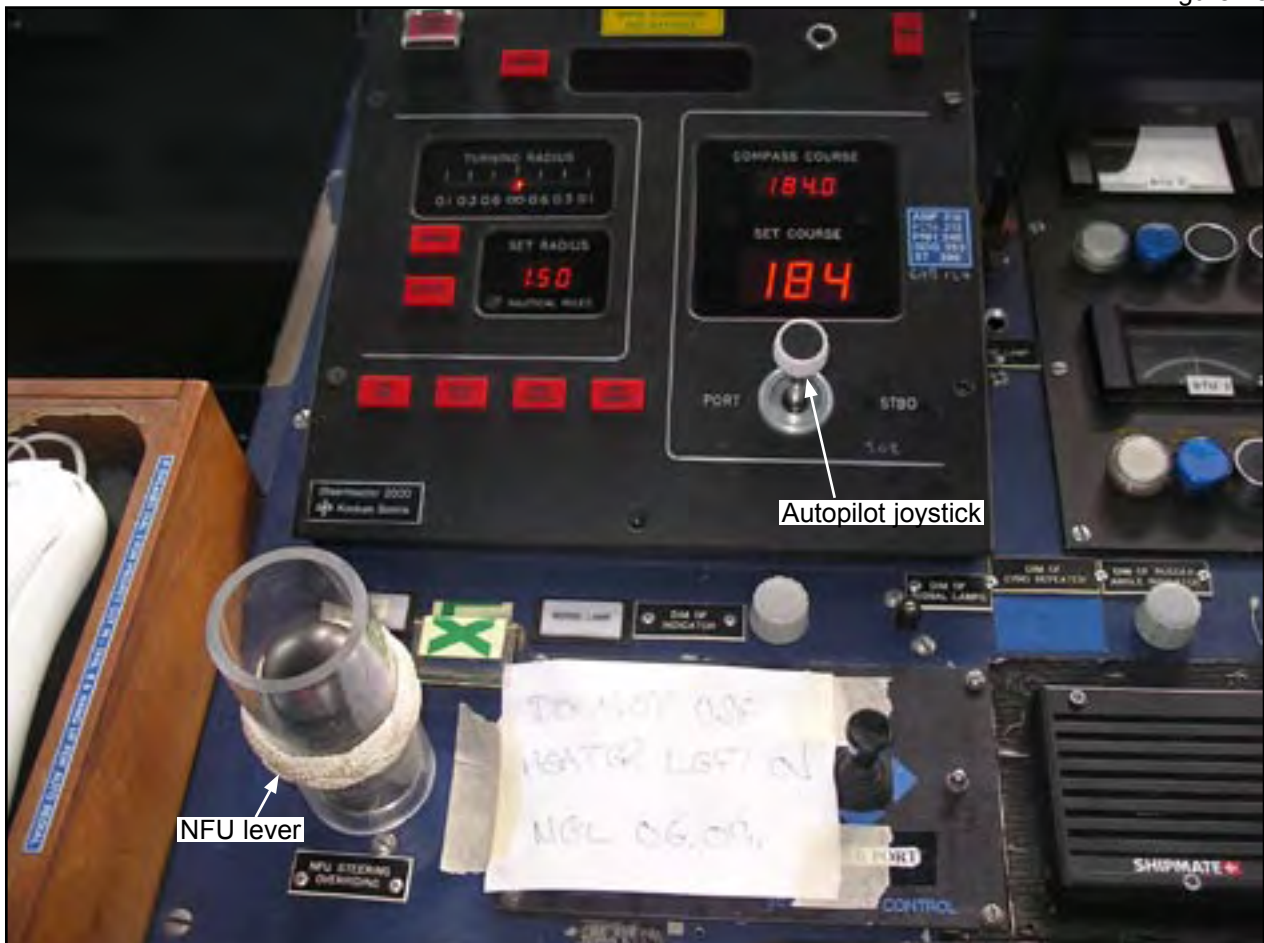
Figure 18

The second officer elected not to use either of these two steering modes, despite the fact that he considered that he urgently needed to turn the vessel quickly to port. Instead, he opted to keep the vessel in autopilot steering mode and adjust the course using the autopilot course input joystick (**Figure 18**).

NFU and autopilot joystick
