Report on the investigation of
the collision between
the container ship

P&O Nedlloyd Vespucci

Wahkuna

**Report No 28/2003
December 2003**

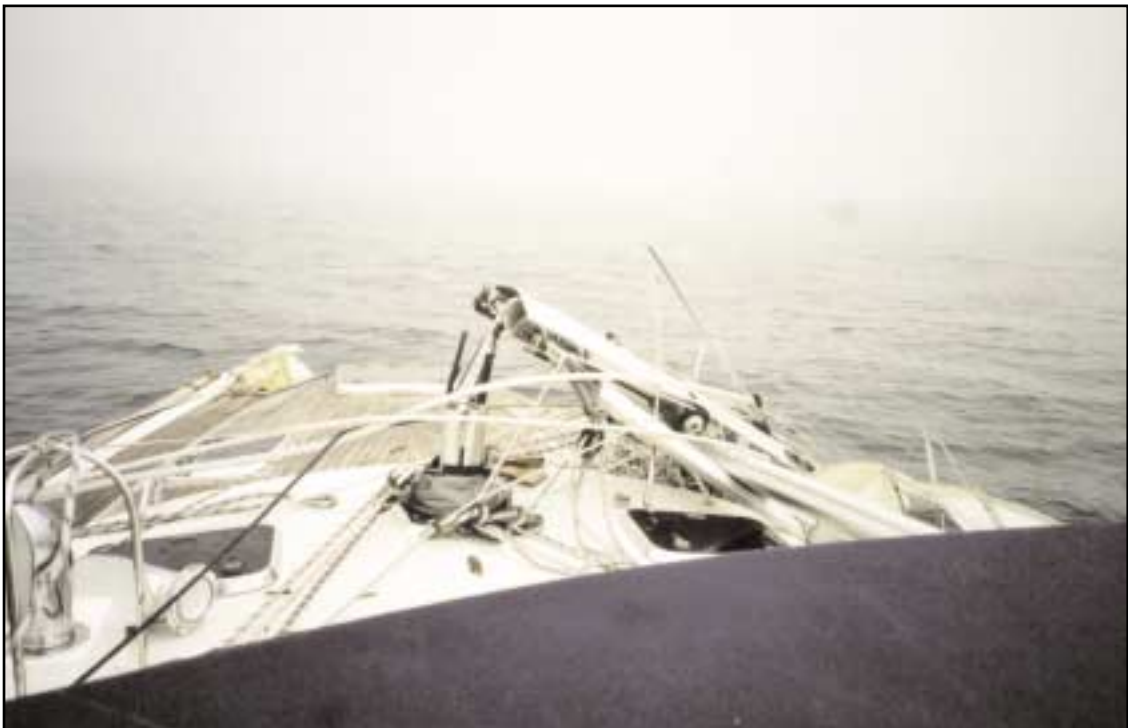
Figure 5

Unfortunately, his actions were unable to prevent a collision. The container vessel's bulbous bow struck the forward part of *Wahkuna*'s port hull, demolishing the first 3 metres of her bow (**Figure 5**).

Photograph of the damage to *Wahkuna*

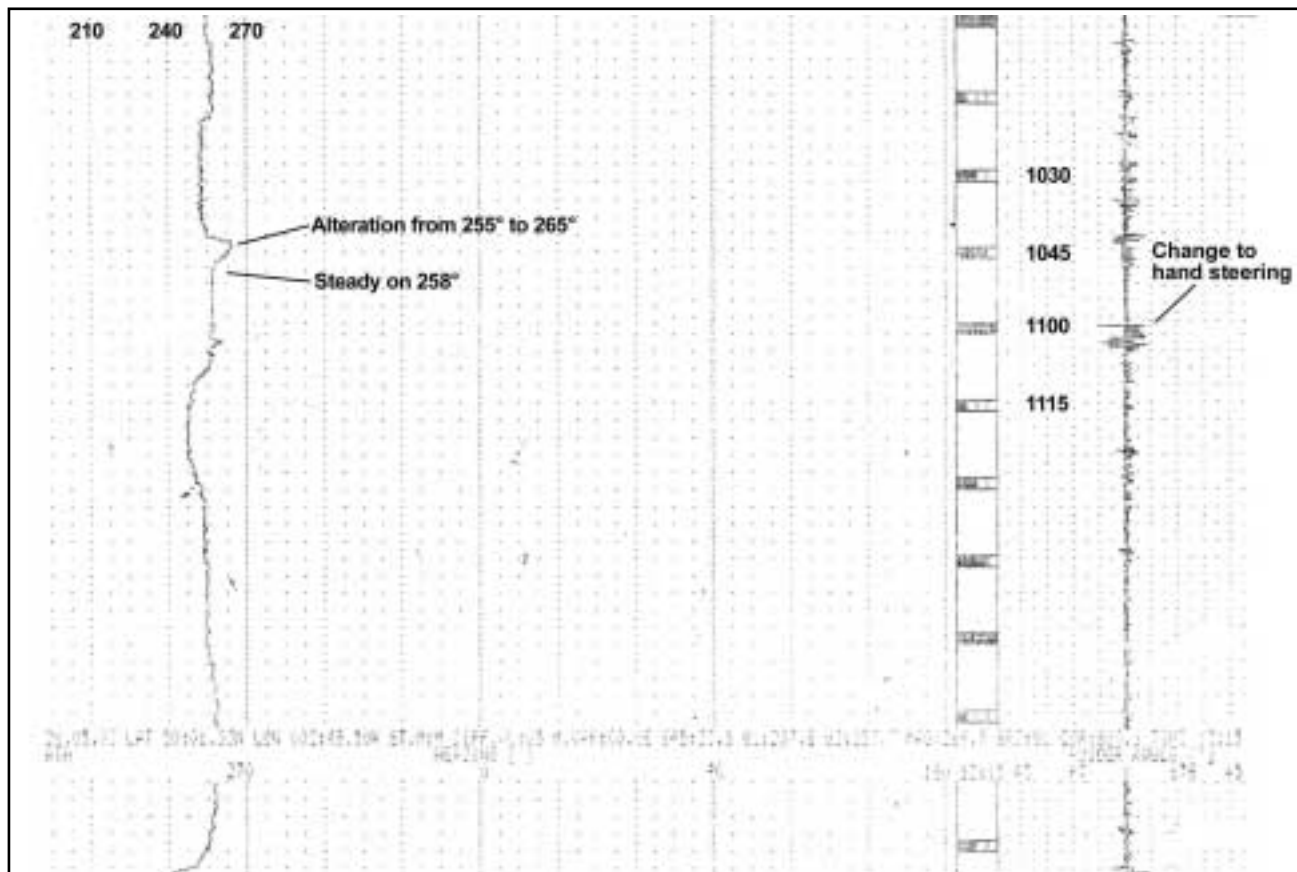
Soon after, another contact was detected on the port bow at a range of between 5 and 6 miles. By ARPA, its course was northerly and speed was 6.5 knots; the master estimated it would cross 8 cables ahead. However, when about one point on the port bow at a range of between 1.5 and 2 miles, the contact slowed quickly and the ARPA vector indicated that it had also altered course towards the north-east. Its speed by ARPA reduced to zero. This concerned the master,

Extract of *P&O Nedlloyd Vespucci's* course recorder

who immediately started the second steering motor and ordered the second officer, who was then the OOW, to change to manual steering. This was done, but neither course nor speed was adjusted.

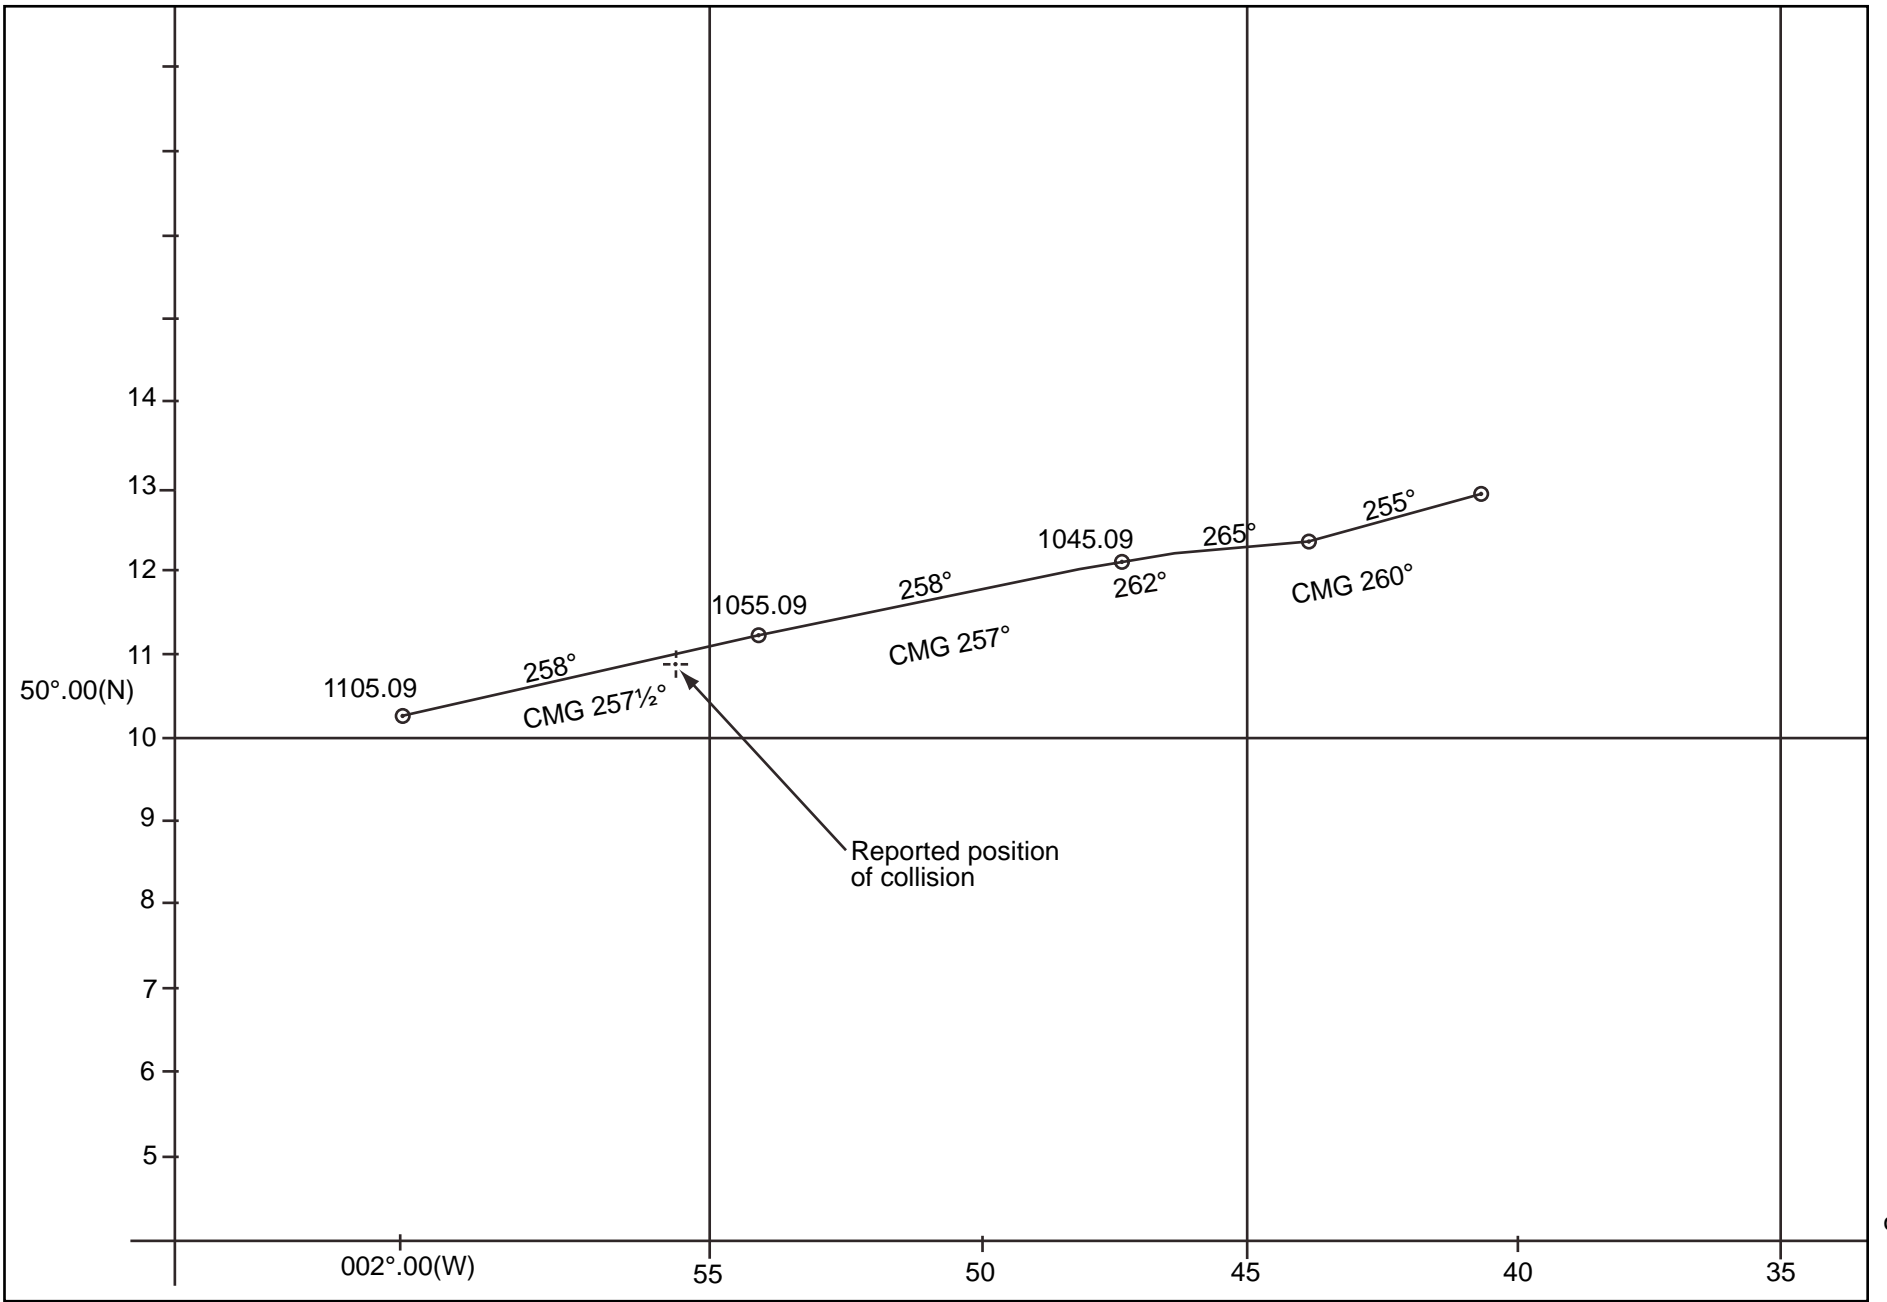
When the bridge team first detected *Wahkuna*, the master was content with the vessel crossing 8 cables ahead. He did not consider this to be a close quarters situation even though given both vessel's courses and speeds, the CPA would have been between 2 to 3 cables to starboard. Consequently, the master took no action.

After the yacht had reduced speed and the CPA by ARPA had changed to 2 cables to port, the master became so concerned by *Wahkuna*'s actions, which were unexpected, that he considered it necessary to change to manual steering and put the OOW on the helm. However, he was confused by the unexpected actions of the yacht to the extent that he was reluctant to take any manoeuvring action because of the uncertainty of what the yacht would do next.

Estimation of the track of *P&O Nedlloyd Vespucci*
